Engineered Log Jams

Flooding Assessment: *Lessons learned from September 2012 Flood Event*

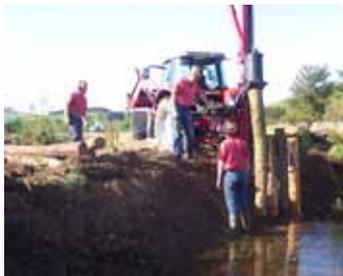
Work underway to install vertical piled timbers as bank protection, Clifton-on-Bowmont, September 2011.

Bank Protection ELJ works have now been completed on three farm sites within the Bowmont Valley (Clifton-on-Bowmont, Swindon Haugh and Kelsocleuch) with variations on design and specification at each site to allow comparisons to be made and lessons learnt with regard to effectiveness. ELJs used for bank protection can be part of a whole farm approach to riverbank erosion stabilisation, as demonstrated at Clifton-on-Bowmont.

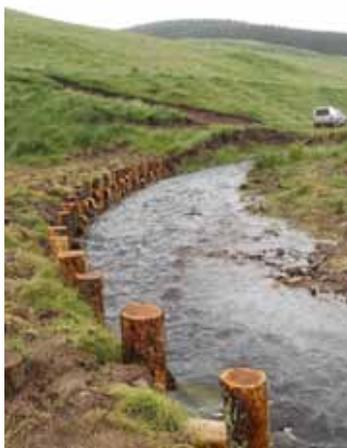
Completed bank protection ELJ works at Kelsocleuch, June 2012.

At **Kelsocleugh** the recently completed logjam works fared reasonably well, reflecting their headwater location and resultant comparative reduced vulnerability. The bar apex logjams all survived intact, as did the structure of both the bank protection and grade control logjam, although some additional erosion of the banks at the grade control site, and some of the backfill material from the bank protection site was evident. We are reasonably confident in our conclusion that the latter was largely due to the flood event occurring so soon after works were completed (approx. 5 weeks), meaning that backfill had insufficient time to settle and consolidate.

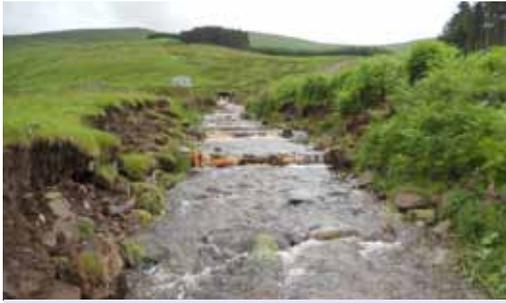
Completed grade control feature on the Kelsocleugh Burn, in the headwaters of the Bowmont catchment, June 2012.

Grade Control ELJ features are intended to assist the repair and natural stabilisation of incised erosion within watercourses. A grade control structure has been completed in the headwaters of the Bowmont in order to regenerate a section of the Kelsocleugh Burn, which has been incised by water dropping from height from a piped bridge structure.

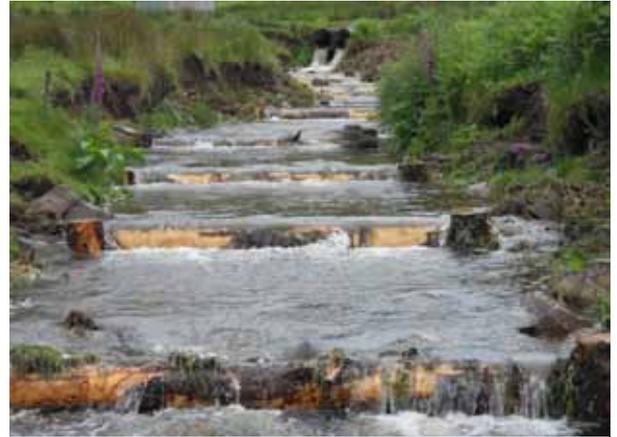
The completed grade control ELJ on the Kelsocleugh Burn, June 2012.
